**Flood Control Project Maintenance
Levee Inspections**

Fall 2016 Levee Maintenance Deficiency Summary Report

Reclamation District No. 0755 Randall

Levee Inspection Report By Mile - Fall 2016

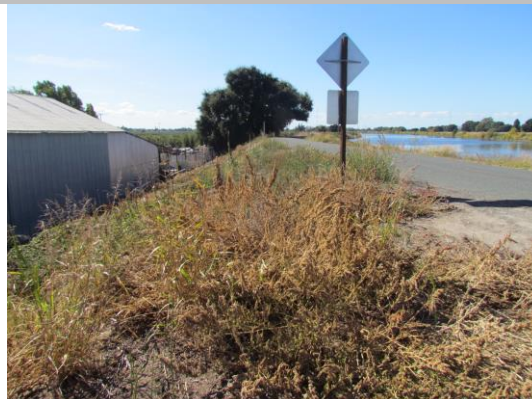
Photo 1 of 1 : FA_2016_RD0755_177_20_20161102_00028.jpg

LM Start	0.17	Rating **	A/W	Issue No.	20
LM End	0.59	Issue Type +	Ma	Location *	LS
Category	Earthen Levee			GPS Latitude/Longitude	
				Start	End
Item	Vegetation			38.346757 °	38.345423 °
				-121.538675 °	-121.546223 °
DWR ID	DWR_RD0755_01_f_2016_20				
Comment Code					
V2 : Remove the wild growth other than native grasses from the levee slopes.					
Inspector Comment					
The vegetation complies with standards but should be monitored, there is some patches of dead growth that should be removed.

RD 755 looking downstream from levee mile 0.17-0.59.

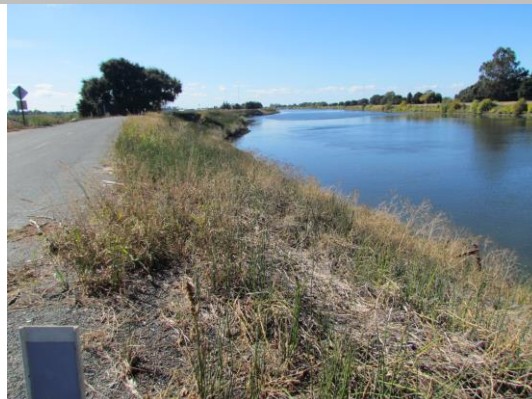
Photo 1 of 1 : FA_2016_RD0755_177_19_20161102_00029.jpg

LM Start	0.17	Rating **	U	Issue No.	19
LM End	1.12	Issue Type +	Ma	Location *	WS
Category	Earthen Levee			GPS Latitude/Longitude	
				Start	End
Item	Vegetation			38.346757 °	38.343328 °
				-121.538675 °	-121.555493 °
DWR ID	DWR_RD0755_01_f_2016_19				
Comment Code					
V2 : Remove the wild growth other than native grasses from the levee slopes.					
Inspector Comment					
The tall weeds on the waterside slope and shoulder should be removed.

RD 755 Levee mile 0.17-1.12 waterside slope looking downstream.

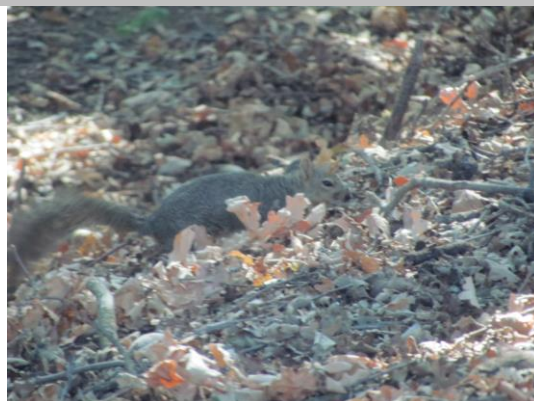
Photo 1 of 1 : FA_2016_RD0755_177_4_20161018_00002.jpg

LM Start	0.43	Rating **	M	Issue No.	4
LM End	1.77	Issue Type +	Ma	Location *	LS
Category	Earthen Levee			GPS Latitude/Longitude	
				Start	End
Item	Animal Control			38.345593 °	38.337197 °
				-121.543263 °	-121.564147 °
DWR ID	DWR_RD0755_01_f_2014_4				
Comment Code					
A1 : Exterminate rodents and backfill and compact or grout burrows.					
Inspector Comment					
There are bait stations along the landside levee slope; rodents are very active in this location near the walnut trees.

One of many active rodent observed during this inspection.

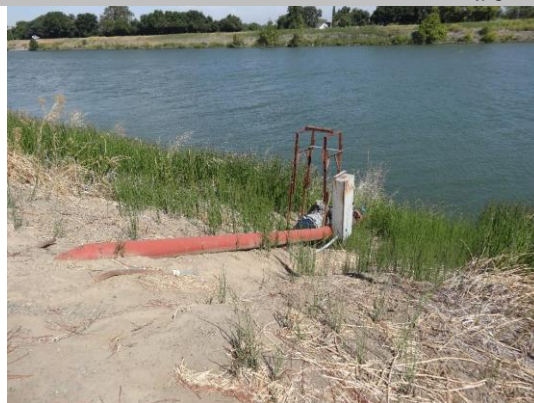
Photo 1 of 2 : UCIP_FA_2016_17123_29242.jpg

LM Start	0.43	Rating **	M	Issue No.	27
LM End	0.43	Issue Type +	En	Location *	LS
Category	Supplemental			GPS Latitude/Longitude	
				Start	End
Item	DWR UCIP Field Study			38.345640 °	38.345640 °
				-121.543277 °	-121.543277 °
DWR ID					
Comment Code					
Inspector Comment					
FS_ID:17123 DS_ID:18849 EP_NO: 4302 Repair Type: Non-Urgent Crossing Status: Found UCIP Comments: FBC about 2 feet.Power conduit also through the leeve.Wet ground on pump site/location. May need investigation about wet ground. FIELD_STRUCT_DESC: 8-inch steel pipe through levee, 2.0 feet below crown. Pump electrical box and control valve on waterward slope. Siphon breaker on landward slope. Service pole at landward toe. (App. No. 4302-Hemly) . FS Date: 8/6/2013

WS view: overview of pump and pipe.

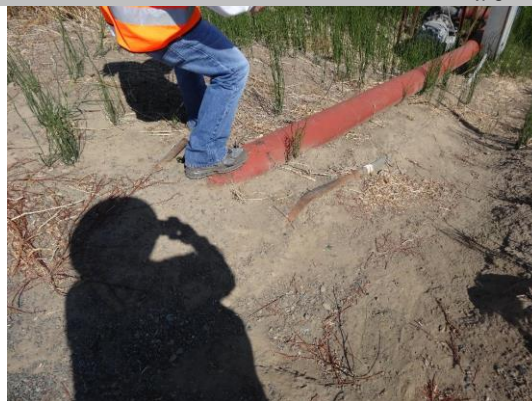
Photo 2 of 2 : UCIP_FA_2016_17123_29241.jpg

LM Start	0.43	Rating **	M	Issue No.	27 (cont)
LM End	0.43	Issue Type +	En	Location *	LS
Category	Supplemental			GPS Latitude/Longitude	
				Start	End
Item	DWR UCIP Field Study			38.345640 °	38.345640 °
				-121.543277 °	-121.543277 °
DWR ID					
Comment Code					
Inspector Comment					
FS_ID:17123 DS_ID:18849 EP_NO: 4302 Repair Type: Non-Urgent Crossing Status: Found UCIP Comments: FBC about 2 feet.Power conduit also through the leeve.Wet ground on pump site/location. May need investigation about wet ground. FIELD_STRUCT_DESC: 8-inch steel pipe through levee, 2.0 feet below crown. Pump electrical box and control valve on waterward slope. Siphon breaker on landward slope. Service pole at landward toe. (App. No. 4302-Hemly) . FS Date: 8/6/2013

WS view: steel pipe and power conduit.

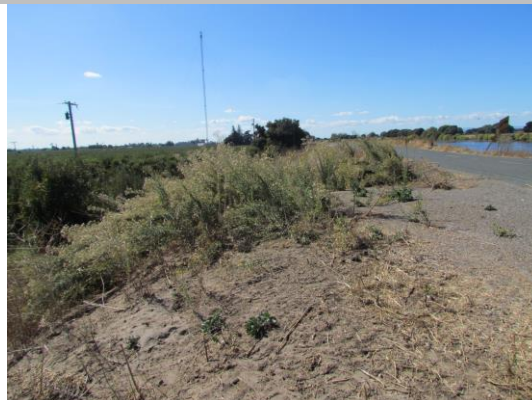
Photo 1 of 1 : FA_2016_RD0755_177_22_20161102_00030.jpg

LM Start	0.59	Rating **	U	Issue No.	22
LM End	0.61	Issue Type +	Ma	Location *	LS
Category	Earthen Levee			GPS Latitude/Longitude	
				Start	End
Item	Vegetation			38.345423 °	38.345375 °
				-121.546223 °	-121.546543 °
DWR ID	DWR_RD0755_01_f_2016_22				
Comment Code					
V1 : Control annual grass and weeds on the levee slopes and easements.					
Inspector Comment					
Remove the tall weed growth from the levee slope and ramp of the landside levee section.

RD 755 looking downstream from landside levee mile 0.59-0.61.

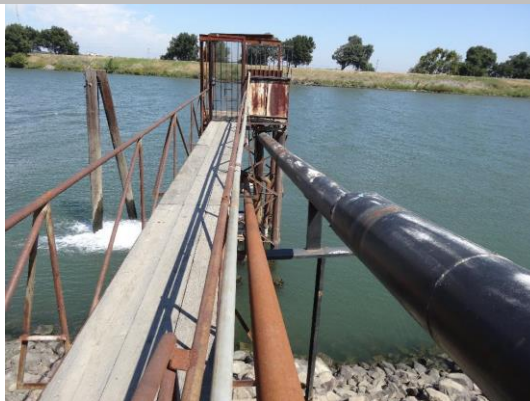
Photo 1 of 2 : UCIP_FA_2016_41634_29087.jpg

LM Start	0.68	Rating **	M	Issue No.	32
LM End	0.68	Issue Type +	En	Location *	LS
Category	Supplemental			GPS Latitude/Longitude	
				Start	End
Item	DWR UCIP Field Study			38.345113 °	38.345113 °
				-121.547789 °	-121.547789 °
DWR ID					
Comment Code					
Inspector Comment					
FS_ID:41634 DS_ID:18851 EP_NO: 7357 Repair Type: Non-Urgent Crossing Status: Found UCIP Comments: An abandoned 12-in steel pipe lying on LS levee slope should be removed.A buried concrete headwall found on LS levee slope should be checked for any pipe or connection. FIELD_STRUCT_DESC: 1 of 2 pipes. 8-inch pipe sleeved through 16-inch pipe, 4.2 feet below crown. 2-inch conduit through levee. (App. No. 7357-Green McKeown, Inc.). O&M Manual Sac 111, May 1959, Revision Year 2011. FS Date: 8/6/2013

WS view: pump structure on the stream, conduit, pipes, and walkway.

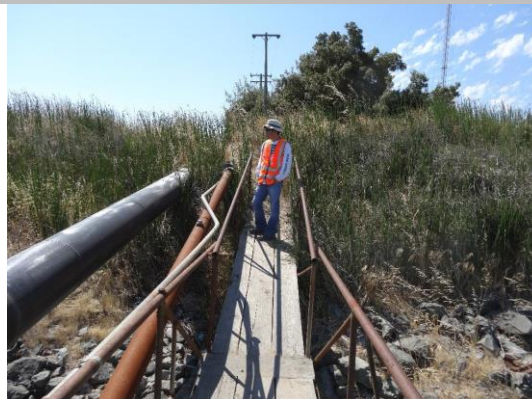
Photo 2 of 2 : UCIP_FA_2016_41634_29086.jpg

LM Start	0.68	Rating **	M	Issue No.	32 (cont)
LM End	0.68	Issue Type +	En	Location *	LS
Category	Supplemental			GPS Latitude/Longitude	
				Start	End
Item	DWR UCIP Field Study			38.345113 °	38.345113 °
				-121.547789 °	-121.547789 °
DWR ID					
Comment Code					
Inspector Comment					
FS_ID:41634 DS_ID:18851 EP_NO: 7357 Repair Type: Non-Urgent Crossing Status: Found UCIP Comments: An abandoned 12-in steel pipe lying on LS levee slope should be removed.A buried concrete headwall found on LS levee slope should be checked for any pipe or connection. FIELD_STRUCT_DESC: 1 of 2 pipes. 8-inch pipe sleeved through 16-inch pipe, 4.2 feet below crown. 2-inch conduit through levee. (App. No. 7357-Green McKeown, Inc.). O&M Manual Sac 111, May 1959, Revision Year 2011. FS Date: 8/6/2013

WS view: view towards levee crown from pump structure.

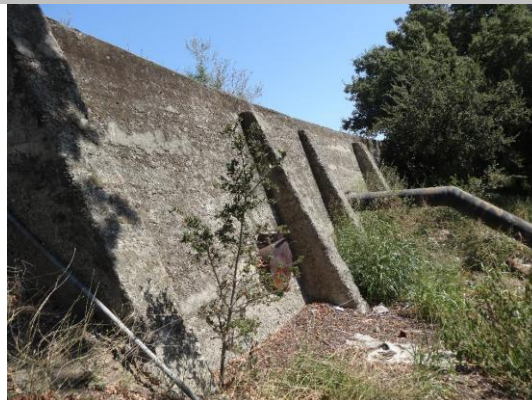
Photo 1 of 2 : UCIP_FA_2016_17049_29119.jpg

LM Start	0.70	Rating **	M	Issue No.	30
LM End	0.70	Issue Type +	En	Location *	LS
Category	Supplemental			GPS Latitude/Longitude	
				Start	End
Item	DWR UCIP Field Study			38.345036 °	38.345036 °
				-121.548141 °	-121.548141 °
DWR ID					
Comment Code					
Inspector Comment					
FS_ID:17049					
DS_ID:18854					
EP_NO: 1716					
Repair Type: Non-Urgent					
Crossing Status: Found					
UCIP Comments: Not found- a 4-inch pipe on waterward shoulder but a 2-inch GI pipe found on landside slope.					
FIELD_STRUCT_DESC: *ABANDONED* 18-inch drainpipe through levee, 4.5 feet below crown. (App. No. 1716-Green McKeown, Inc.).					
O&M Manual Sac 111, May 1959, Revision Year 2011.					
FS Date: 8/6/2013

LS view: concrete headwall and 2-inch conduit (left)

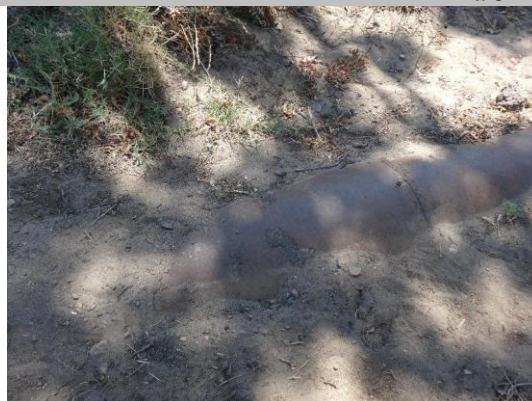
Photo 2 of 2 : UCIP_FA_2016_17049_29121.jpg

LM Start	0.70	Rating **	M	Issue No.	30 (cont)	
LM End	0.70	Issue Type +	En	Location *	LS	
Category	Supplemental			GPS Latitude/Longitude		
				Start	End	
Item	DWR UCIP Field Study			38.345036 °	38.345036 °	
				-121.548141 °	-121.548141 °	
DWR ID						
Comment Code						
Inspector Comment						
FS_ID:17049						
DS_ID:18854						
EP_NO: 1716						
Repair Type: Non-Urgent						
Crossing Status: Found						
UCIP Comments: Not found- a 4-inch pipe on waterward shoulder but a 2-inch GI pipe found on landside slope.						
FIELD_STRUCT_DESC: *ABANDONED* 18-inch drainpipe through levee, 4.5 feet below crown. (App. No. 1716-Green McKeown, Inc.).						
O&M Manual Sac 111, May 1959, Revision Year 2011.						
FS Date: 8/6/2013

LS view: 18-inch abandoned pipe on levee slope

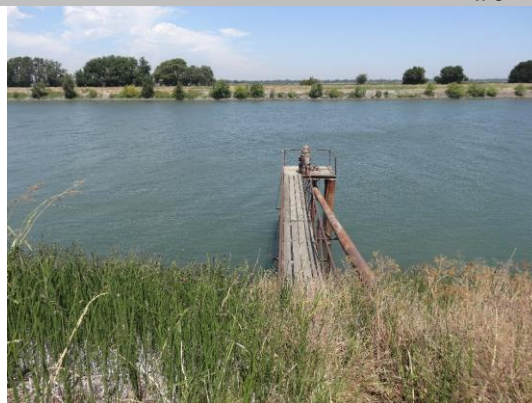
Photo 1 of 2 : UCIP_FA_2016_17063_29148.jpg

LM Start	0.93	Rating **	M	Issue No.	31
LM End	0.93	Issue Type +	En	Location *	LS
Category	Supplemental			GPS Latitude/Longitude	
				Start	End
Item	DWR UCIP Field Study			38.344103 °	38.344103 °
				-121.552119 °	-121.552119 °
DWR ID					
Comment Code					
Inspector Comment					
FS_ID:17063 DS_ID:18855 EP_NO: 11225 Repair Type: Non-Urgent Crossing Status: Found UCIP Comments: Abandoned pipe and pump.Service pole, power box lying on LS slope. FIELD_STRUCT_DESC: *ABANDONED* 10-inch pipe and 1-inch conduit through levee, 5.6 feet below crown, pump on pile structure with walkway to pump. Abandoned service pole on landward slope. (ABO No. 11225- Wilson).O&M Manual Sac 111, May 1959, Revision Year 2011. FS Date: 8/6/2013

WS view: overview of pipe and pump structure.

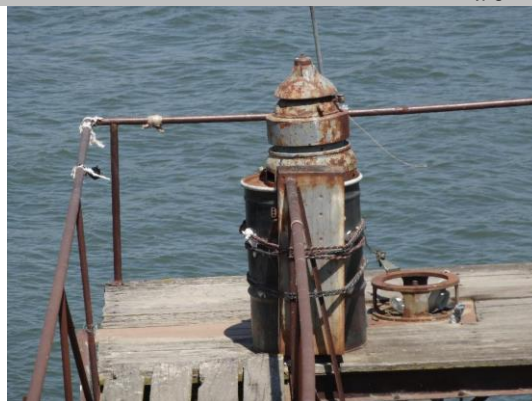
Photo 2 of 2 : UCIP_FA_2016_17063_29147.jpg

LM Start	0.93	Rating **	M	Issue No.	31 (cont)
LM End	0.93	Issue Type +	En	Location *	LS
Category	Supplemental			GPS Latitude/Longitude	
				Start	End
Item	DWR UCIP Field Study			38.344103°	38.344103°
				-121.552119°	-121.552119°
DWR ID					
Comment Code					
Inspector Comment					
FS_ID:17063 DS_ID:18855 EP_NO: 11225 Repair Type: Non-Urgent Crossing Status: Found UCIP Comments: Abandoned pipe and pump.Service pole, power box lying on LS slope. FIELD_STRUCT_DESC: *ABANDONED* 10-inch pipe and 1-inch conduit through levee, 5.6 feet below crown, pump on pile structure with walkway to pump. Abandoned service pole on landward slope. (ABO No. 11225- Wilson).O&M Manual Sac 111, May 1959, Revision Year 2011. FS Date: 8/6/2013

WS view: an abandoned pump

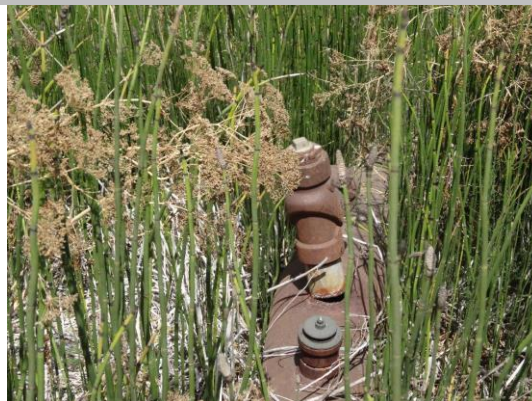
Photo 2 of 2 : UCIP_FA_2016_46764_29157.jpg

FS_ID:46764
DS_ID:18856
EP_NO: N/A
Repair Type: Non-Urgent
Crossing Status: Found
UCIP Comments: Needs to be properly abandoned.
FIELD_STRUCT_DESC: *ABANDONED* 12-inch pipe through levee, 5.0 feet below crown. Siphon breaker on WS, no pipe found on LS. (Cat. IVA-Wilson). O&M Manual Sac 111, May 1959, Revision Year 2011.
FS Date: 8/6/2013

WS view: steel pipe with siphon breaker on levee slope

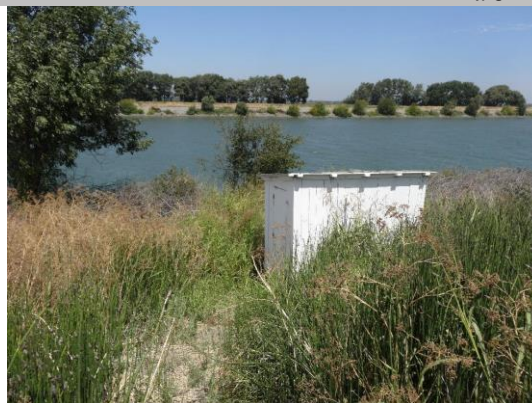
Photo 1 of 2 : UCIP_FA_2016_17144_29288.jpg

LM Start	1.12	Rating **	M	Issue No.	29
LM End	1.12	Issue Type +	En	Location *	WS
Category	Supplemental			GPS Latitude/Longitude	
				Start	End
Item	DWR UCIP Field Study			38.343305 °	38.343305 °
				-121.555538 °	-121.555538 °
DWR ID					
Comment Code					
Inspector Comment					
FS_ID:17144					
DS_ID:18857					
EP_NO: 11219					
Repair Type: Non-Urgent					
Crossing Status: Found					
UCIP Comments: - requires cleaning of siphon breaker box.					
FIELD_STRUCT_DESC: 8-inch pipe through levee, 5.7 feet below crown. Siphon breaker inside CM Pipe riser on landside shoulder. Power pole on landside. Pump and power box in pump house on waterward slope. (ABO No. 11219- Elliott). O&M Manual Sac 111, May 1959, Revision Year 2011.					
FS Date: 8/6/2013

WS view: pump house on levee slope.

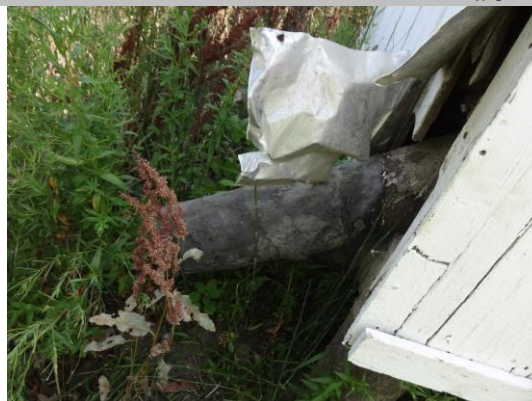
Photo 2 of 2 : UCIP_FA_2016_17144_29287.jpg

LM Start	1.12	Rating **	M	Issue No.	29 (cont)
LM End	1.12	Issue Type +	En	Location *	WS
Category	Supplemental			GPS Latitude/Longitude	
				Start	End
Item	DWR UCIP Field Study			38.343305 °	38.343305 °
				-121.555538 °	-121.555538 °
DWR ID					
Comment Code					
Inspector Comment					
FS_ID:17144					
DS_ID:18857					
EP_NO: 11219					
Repair Type: Non-Urgent					
Crossing Status: Found					
UCIP Comments: - requires cleaning of siphon breaker box.					
FIELD_STRUCT_DESC: 8-inch pipe through levee, 5.7 feet below crown. Siphon breaker inside CM Pipe riser on landside shoulder.Power pole on landside. Pump and power box in pump house on waterward slope. (ABO No. 11219- Elliott). O&M Manual Sac 111, May 1959, Revision Year 2011.					
FS Date: 8/6/2013

WS view: pipe daylight from pump house.

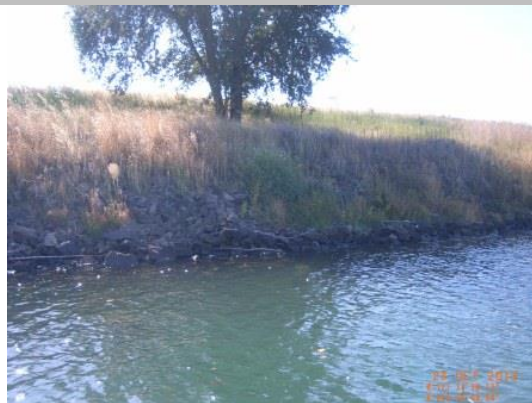
Photo 1 of 1 : FA_2016_RD0755_177_1_20161018_00001.jpg

LM Start	1.24	Rating **	M	Issue No.	1
LM End	1.32	Issue Type +	Ma	Location *	WS
Category	Supplemental			GPS Latitude/Longitude	
				Start	End
Item	2015 USACE Erosion Survey, DRAFT			38.343071 °	38.342426 °
				-121.557706 °	-121.559163 °
DWR ID	DWR_RD0755_01_f_2016_1

Comment Code					
Inspector Comment					
2003 - Toe and lower slope eroding, rock in water and a few pieces on the slope; rock at upstream and downstream ends. 2005 - Looks a little worse. Two major holes with vertical banks and smaller intermittent pockets in between. Stone is present upstream, downstream, and at toe. 2008 - Repaired at both ends (50 ft of new stone) but middle remains unrepaired. 2011 - Site extended downstream to include new scour. 2013 - At the downstream end, behind tree, there is a new animal burrow. Tree has exposed roots. 2015: New rock placed at toe in middle of site, hole remains behind the tree. [2015 Site ID: SAC_35-4_L]

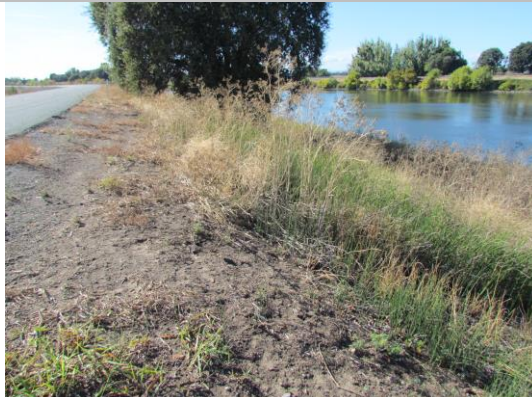
Photo 1 of 1 : FA_2016_RD0755_177_25_20161102_00031.jpg

LM Start	1.27	Rating **	U	Issue No.	25
LM End	1.72	Issue Type +	Ma	Location *	WS
Category	Earthen Levee			GPS Latitude/Longitude	
				Start	End
Item	Vegetation			38.342695 °	38.337757 °
				-121.558108 °	-121.563637 °
DWR ID	DWR_RD0755_01_f_2016_25				
Comment Code					
V1 : Control annual grass and weeds on the levee slopes and easements.					
Inspector Comment					
The wild weed growth at this location need to be controlled.

RD 755 waterside slope looking downstream from levee mile 1.27-1.72.

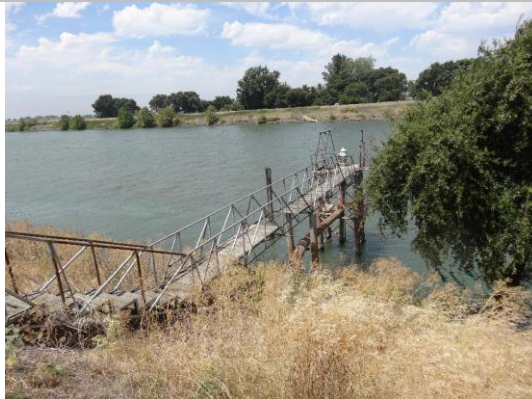
Photo 1 of 2 : UCIP_FA_2016_17143_29282.jpg

LM Start	1.64	Rating **	M	Issue No.	28
LM End	1.64	Issue Type +	En	Location *	WS
Category	Supplemental			GPS Latitude/Longitude	
				Start	End
Item	DWR UCIP Field Study			38.338715 °	38.338715 °
				-121.562560 °	-121.562560 °
DWR ID					
Comment Code					
Inspector Comment					
FS_ID:17143 DS_ID:18858 EP_NO: 11219 Repair Type: Non-Urgent Crossing Status: Found UCIP Comments: - Pump and walkway seem abandoned.- Power line is not connected with pump.- A pump house like structure found on LS levee toe. FIELD_STRUCT_DESC: 16-inch pipe through levee, 8.5 feet below crown. Pump on pile structure in stream. Walkway to pump. Siphon breaker and power pole on landward slope. (ABO No. 11219-Elliott). O&M Manual Sac 111, May 1959, Revision Year 2011. FS Date: 8/6/2013

WS view: Overview of walkway, pump structure, and pipe.

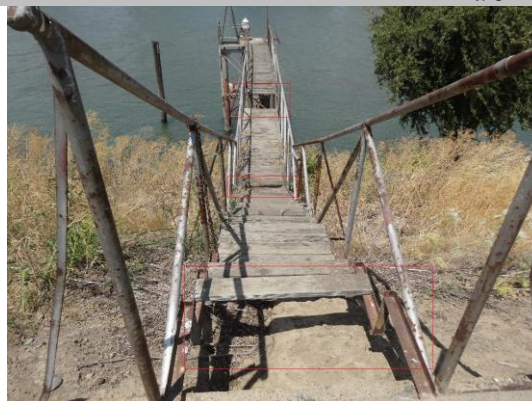
Photo 2 of 2 : UCIP_FA_2016_17143_29281.jpg

LM Start	1.64	Rating **	M	Issue No.	28 (cont)
LM End	1.64	Issue Type +	En	Location *	WS
Category	Supplemental			GPS Latitude/Longitude	
				Start	End
Item	DWR UCIP Field Study			38.338715 °	38.338715 °
				-121.562560 °	-121.562560 °
DWR ID					
Comment Code					
Inspector Comment					
FS_ID:17143 DS_ID:18858 EP_NO: 11219 Repair Type: Non-Urgent Crossing Status: Found UCIP Comments: - Pump and walkway seem abandoned.- Power line is not connected with pump.- A pump house like structure found on LS levee toe. FIELD_STRUCT_DESC: 16-inch pipe through levee, 8.5 feet below crown. Pump on pile structure in stream. Walkway to pump. Siphon breaker and power pole on landward slope. (ABO No. 11219-Elliott). O&M Manual Sac 111, May 1959, Revision Year 2011. FS Date: 8/6/2013

WS view: Abandoned walkway and pump structure
